## 1109, Winchester

| Project | 2018 CSI GPS |
| Geodetic Code | 1109 |
| Station Name | Winchester |

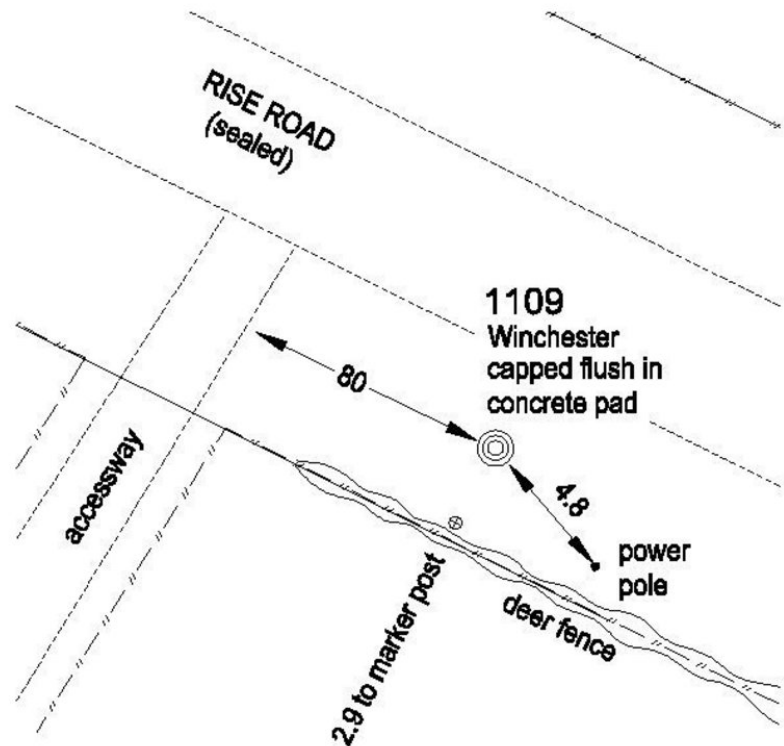
Diagram

| Access and Location Description | Trig is located 2.7km SE of Winchester along Rise Road. From south look for AA sign "Rise Road" just past the 50km/hr sign. War memorial obelisk is located at the corner. Turn left and proceed 2.7km along road. The trig is on the right hand side of the road beside a concrete power pole and is marked by new blue marker post. New concrete pad (with leg holes) with metal cover (probably need tool to remove-it stuck). A farmhouse on the left is located about 50-100m past (SE) of trig. |

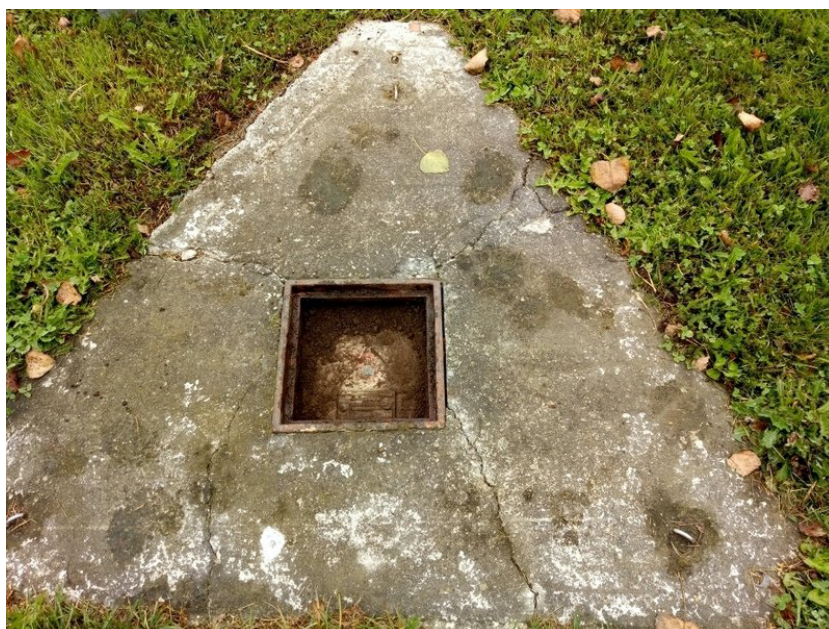
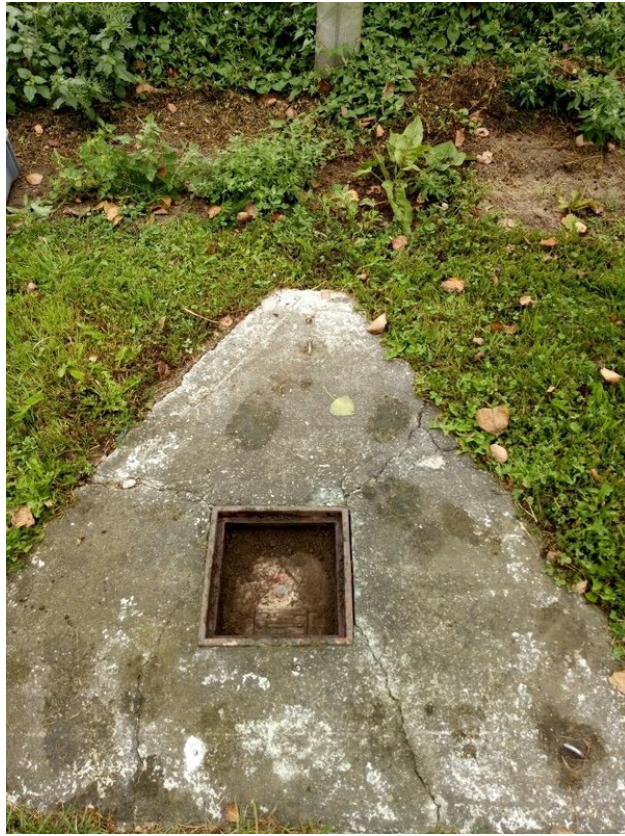
Photo of Survey Mark

| Mark Type | Stainless Steel Pin |
| Mark Physical State | Reliable / Found |
| Mark Description | This mark is used for deformation monitoring, do not alter the ground mark in any way. PIN in concrete capped. Brass plaque set in concrete. |

| Primary Protection | Cast Iron Cover |
| Secondary Protection | Wooden or Non-Standard Marker Post |
