## A4P8, PQ Mt Mark

| Project | 2018 CSI GPS |
| Station Name | PQ Mt Mark |

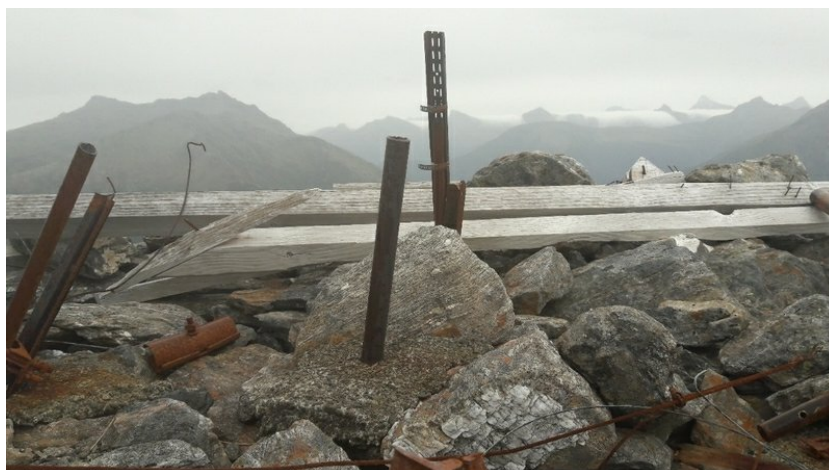
Photo of Survey Mark

| Deployment Status Comment | Mark destroyed. 2m Nelson Beacon has been cut down and iron tube is bent over. Concrete block which contains iron tube is loosely sitting on surface amongst rubble. |

| Mark Physical State | Damaged |
| Mark Description | This mark is used for deformation monitoring, do not alter the ground mark in any way. 1" tube and is on a lean. It appears to have been fixed into this position. |

| Additional Beacon Notes (GNS use only) | Beacon is lying on its side next to mark. Badly damaged by either lightning strike and/or high winds. |

| Additional mark or site notes (GNS use only) | There are some nearby (car sized) boulders which may be useful for reestablishing a new site. Summit is composed of loose boulder sized rubble, not suitable for a new mark. |

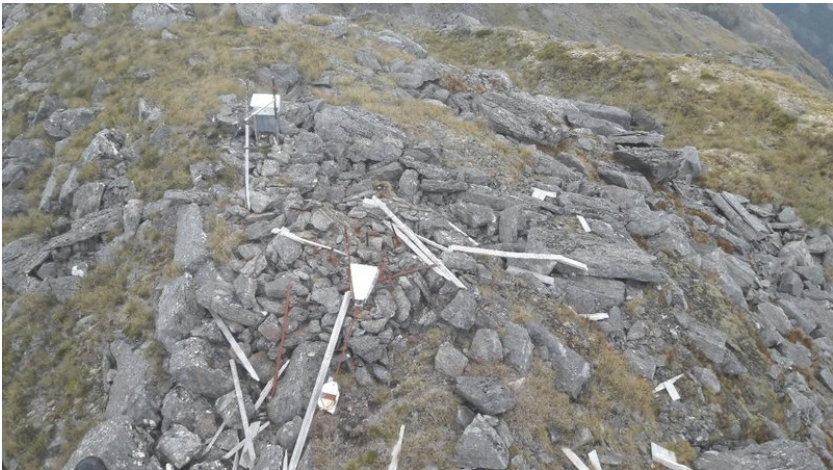
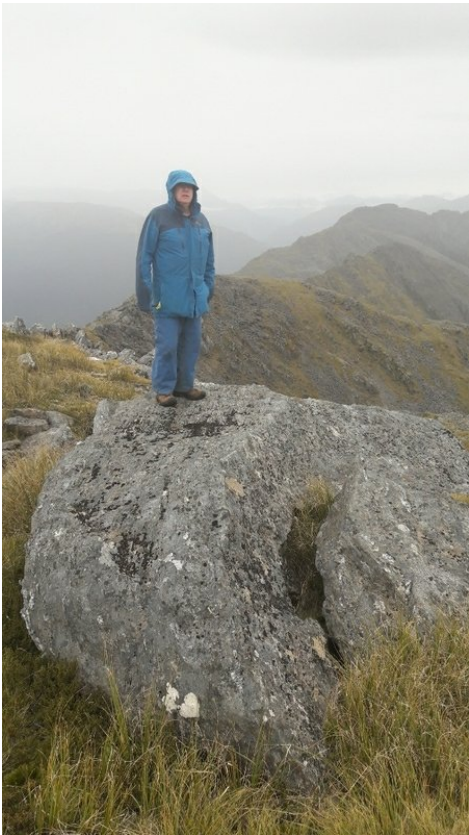
Photo of Extended Site

| Access and Location Description | Helicopter. Good landing place on flat ledge approximately 20 m to the south-east of summit of Mt. Marks. Helicopter can easily get both skids down. |
