## AAD3, C Sugarloaf

| Project | 2018 CSI GPS |
| Geodetic Code | AAD3 |
| Station Name | C Sugarloaf |

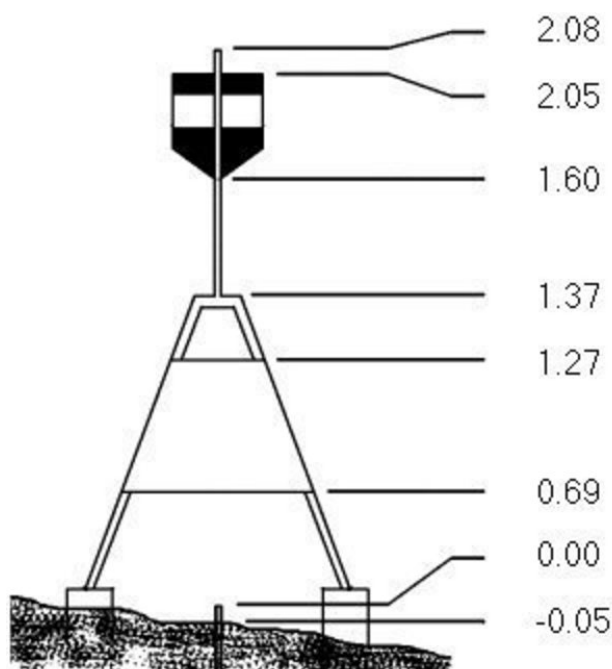
Existing Beacon Diagram (read only).

| Beacon Type | 2m Metal Beacon, Clarke, Nelson, Gisborne |

Previously Recorded Eccentricity 90Deg 0.07:Now Central

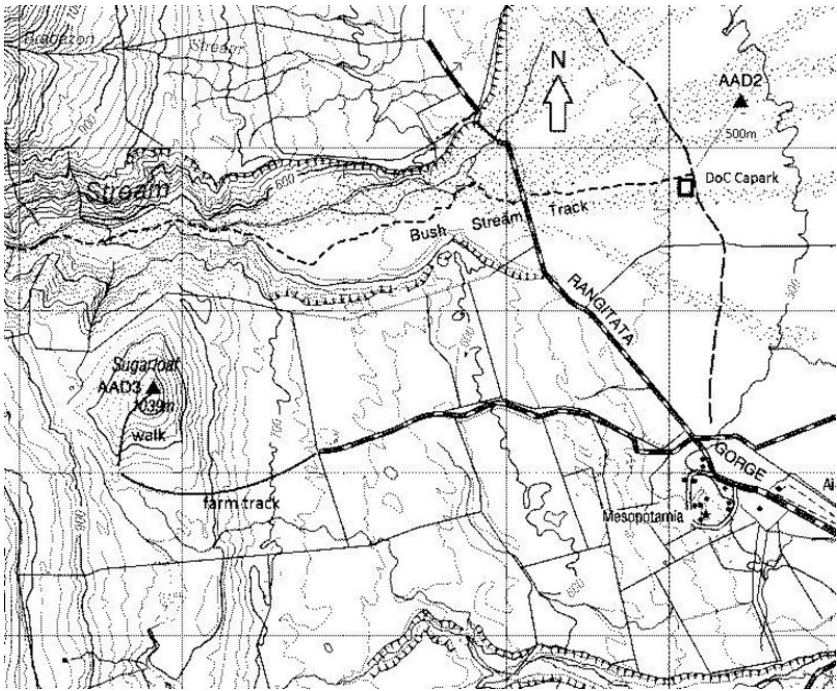
Diagram Notes

Use locus GPS track. In return the first track is the walking part and the second is the driving part

Take major left hand turn just past station house. The correct fork can be seen climbing up a hill steeply from the intersection. Follow road up high terrace (Butler Downs) and then straight to the Sugar loaf. Road veers south around prominent south ridge from Sugar loaf and continues to a high flat basin. From here the trig, which is located on the summit can be reached by climbing a moderate tussock hill side for about 200m. The site has a Nelson beacon in good condition.

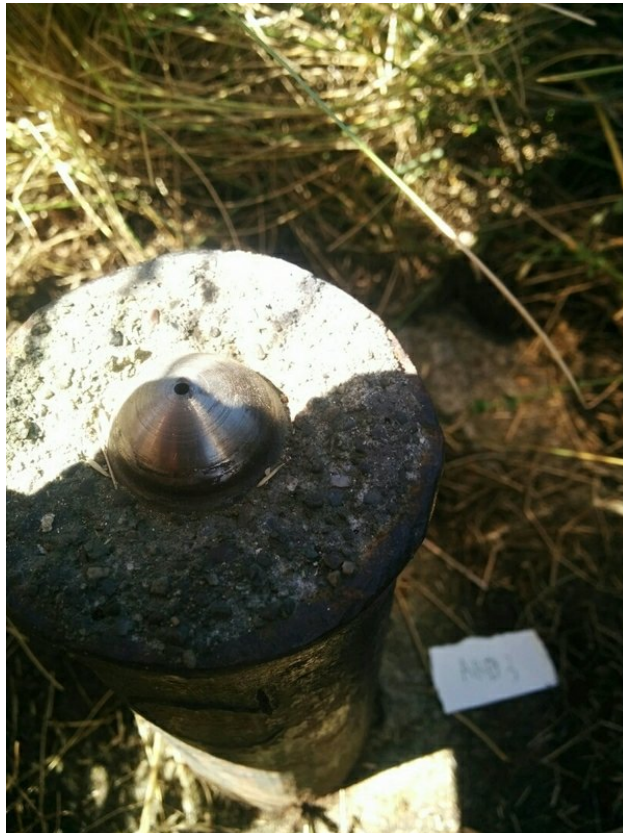
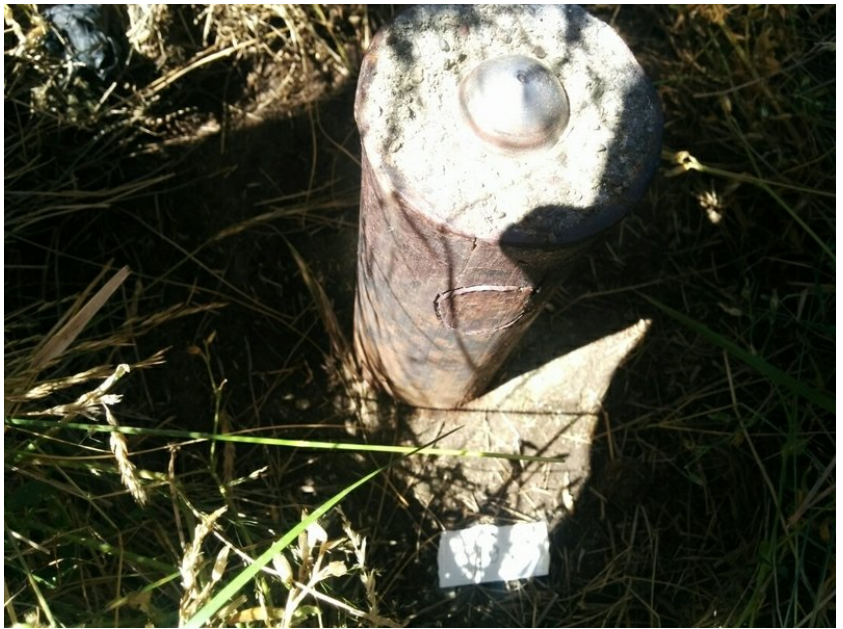
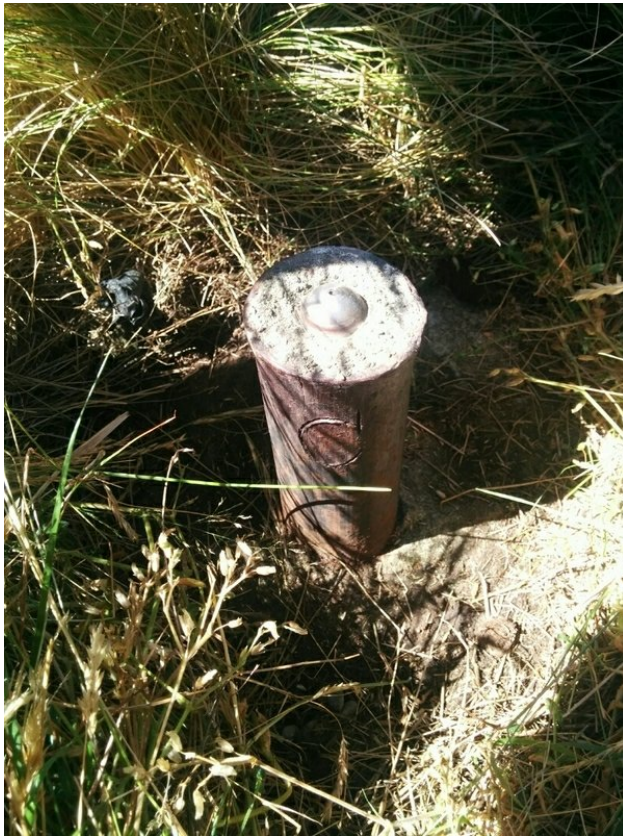
Photo of Survey Mark

| Mark Description | This mark is used for deformation monitoring do not alter the ground mark in any way. SS pin in 0.05m dia tube in earth mound. Branded 'C'. Buried mark not known. No pin. |
