## AF5R, Stag Saddle

| Project | 2018 CSI GPS |
| Geodetic Code | AF5R |
| Station Name | Stag Saddle |

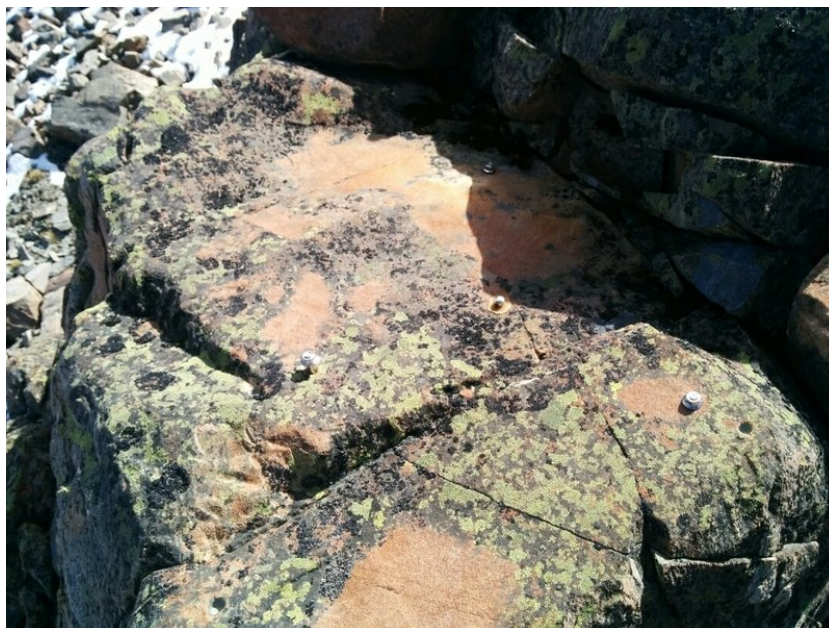
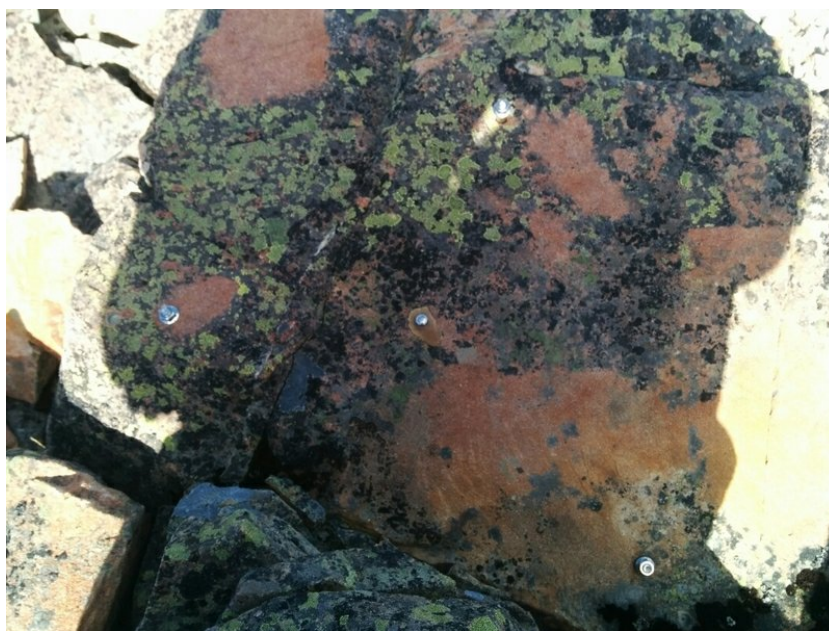
Photo of Survey Mark

| Mark Description | This mark is used for deformation monitoring, do not alter the ground mark in any way. 12mm Stainless steel pin epoxied in rock. 3 x dynabolts in place. |

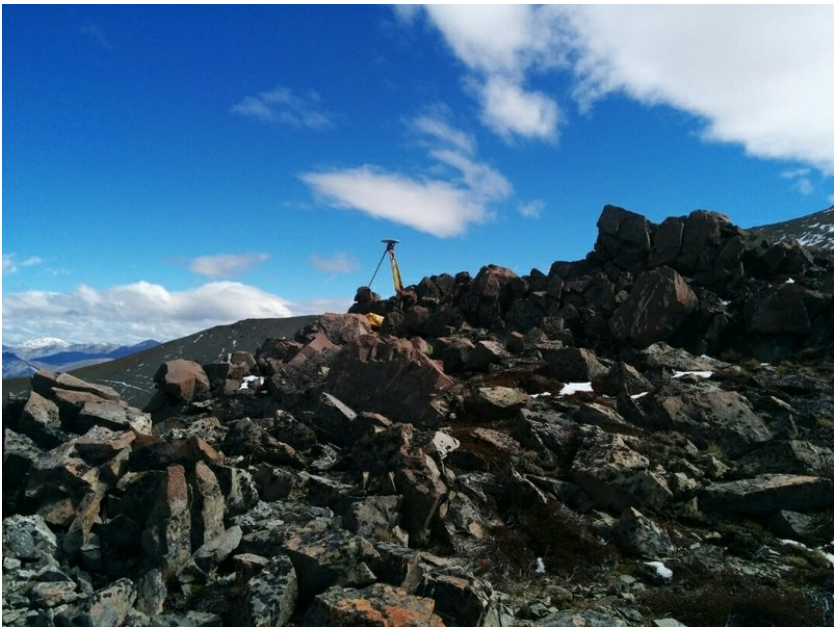
Photo of Extended Site

Locating Stag Pass, there is a broad flat area on the ridge 200m NW of stag saddle where a helicopter can land. To the SE of this area there is a rocky knoll composed of dark rocks overlooking the valley leading towards L. Tekapo, which contains the mark. Knoll is shown as a small closed contour on I36 (1:50000 260series). Station is 5m at 192' magnetic from top of knoll on a flat slab above 2-3m cliff. (In 1996 there were a pair of deer antlers wedged in the rock about 1m from the station. Still there but several metres away in 2010.)
