## B7UY, The Pivot No 2

| Project | 2018 CSI GPS |
| Geodetic Code | B7UY |
| Station Name | The Pivot No 2 |

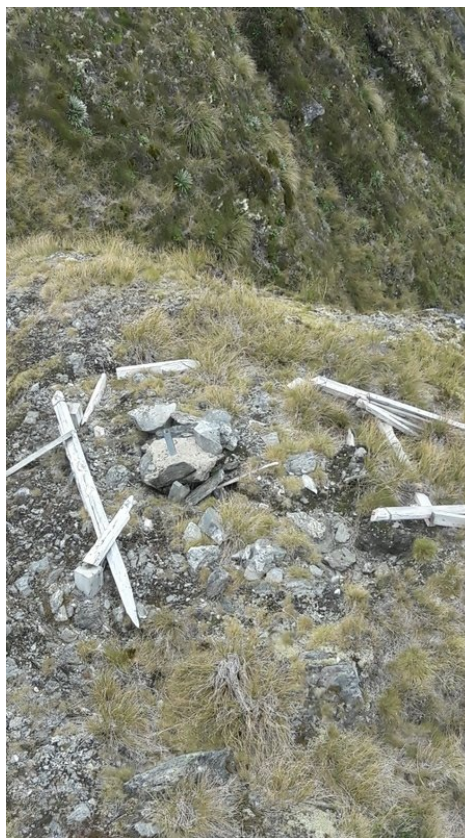
Photo of Survey Mark

| Deployment Status Comment | Mark has been destroyed by lightning. |

| Mark Physical State | Destroyed |
| Additional mark or site notes (GNS use only) | Mark has been destroyed. Concrete block which contains mark has been blown out of the ground and the remains of the beacon are strewn around the summit. |
