## B8XE, Lake Camp

| Project | 2018 CSI GPS |
| Geodetic Code | B8XE |
| Station Name | Lake Camp |

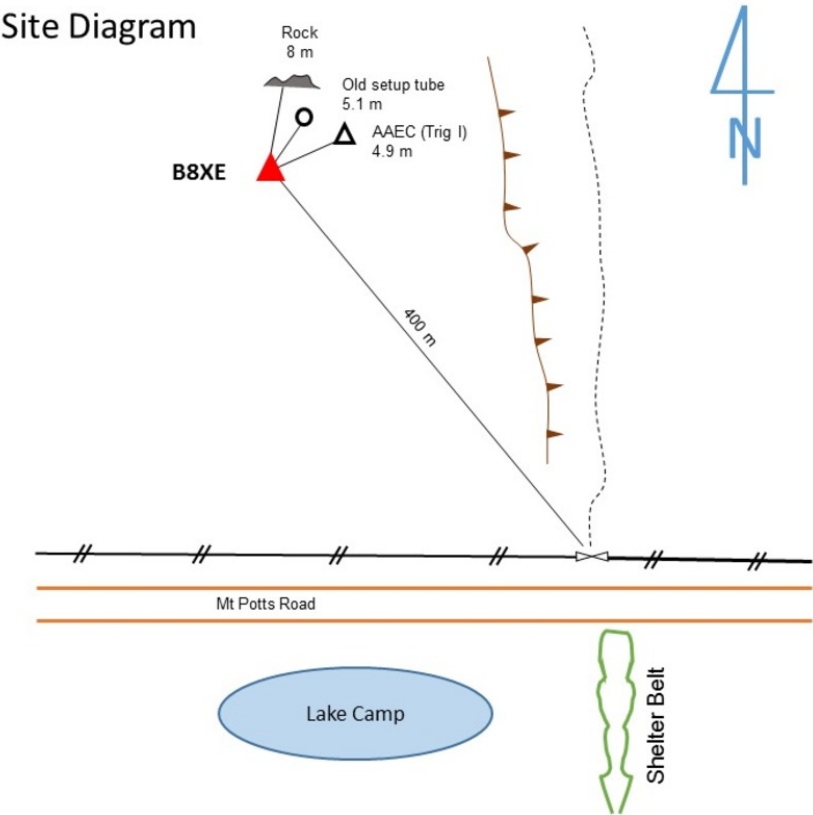
| Diagram Notes | site diagram updated |

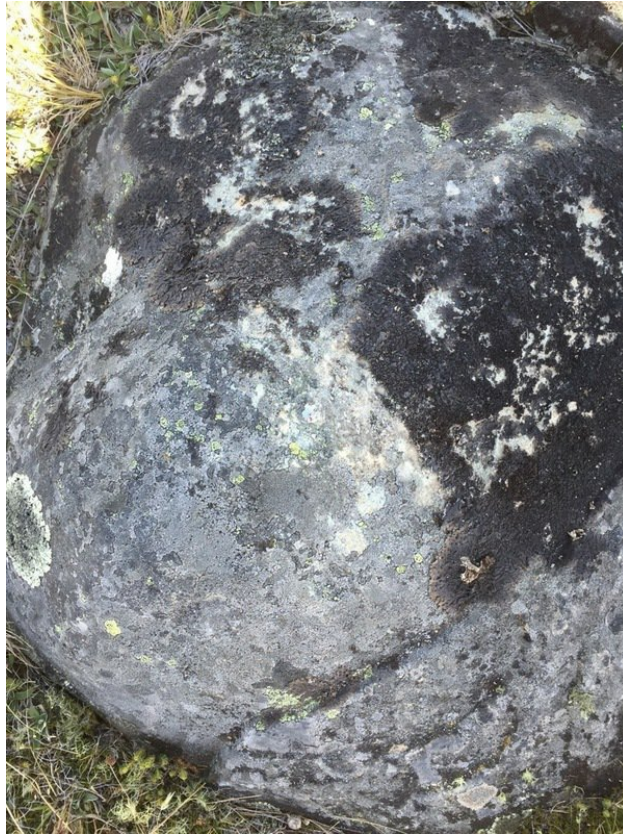
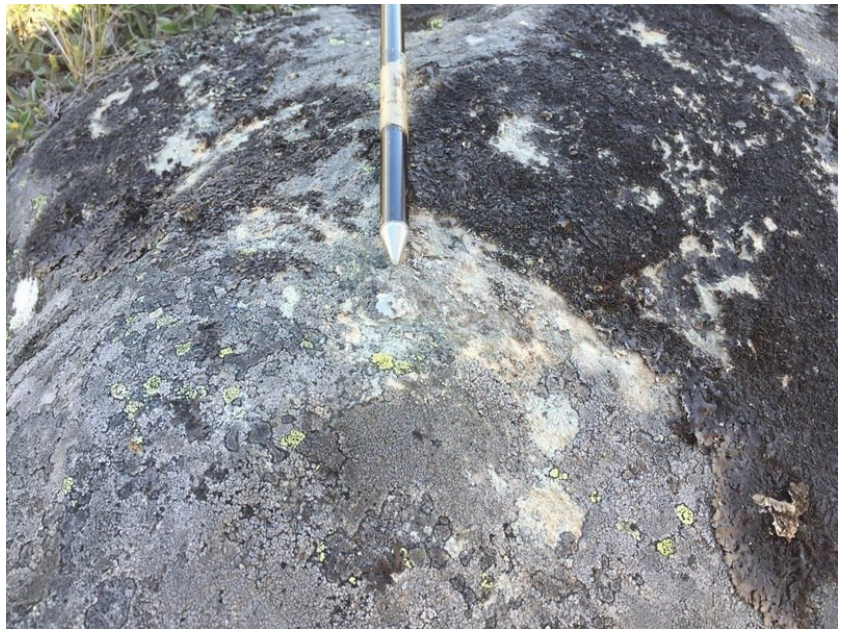
Photo of Survey Mark

| Mark Description | This mark is used for deformation monitoring, do not alter the ground mark in any way. Stainless steel pin set in buried boulder. |
| Additional mark or site notes (GNS use only) | Mark may be difficult to locate on rock due to lichen. |

| Additional access notes (GNS use only) | Jan 2018: Rock and mark covered in lichen. In the future, may have to scratch off lichen to find mark. |
