## B8XT, Devastation

| Project | 2018 CSI GPS |
| Geodetic Code | B8XT |
| Station Name | Devastation |

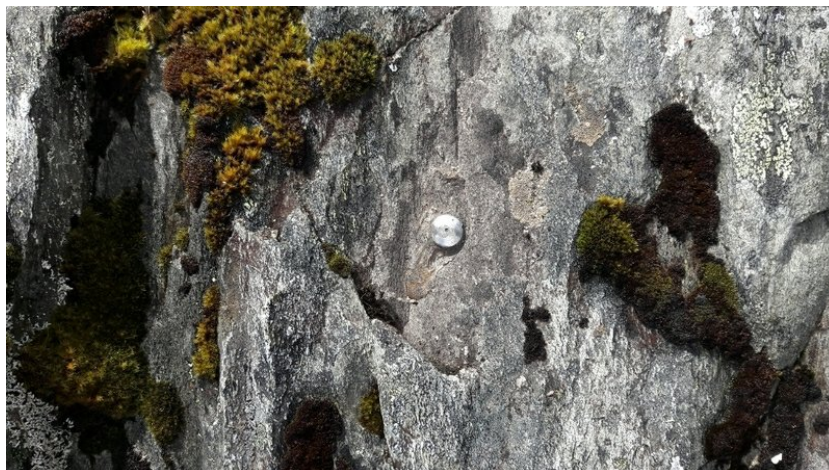
Photo of Survey Mark

| Mark Type | Stainless Steel Pin |
| Mark Physical State | Reliable / Found |
| Mark Description | This mark is used for deformation monitoring, do not alter the ground mark in any way. Stainless steel pin set in rock outcrop. |
| Additional mark or site notes (GNS use only) | Cairn used to mark location of pin in large north facing boulder outcrop |

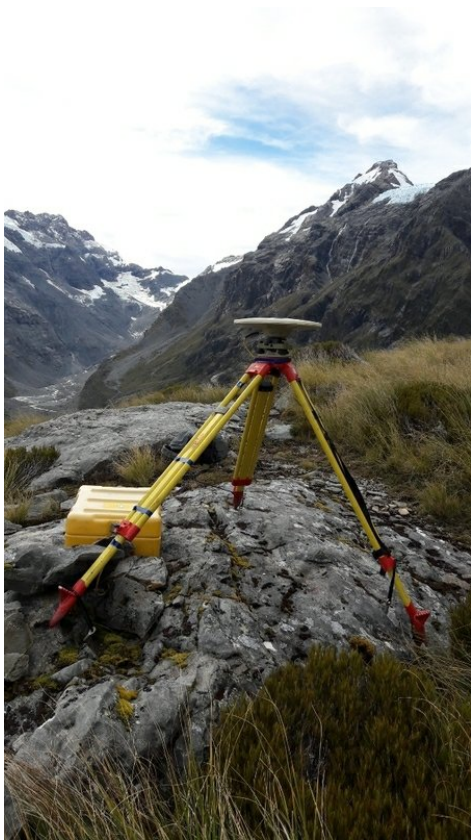
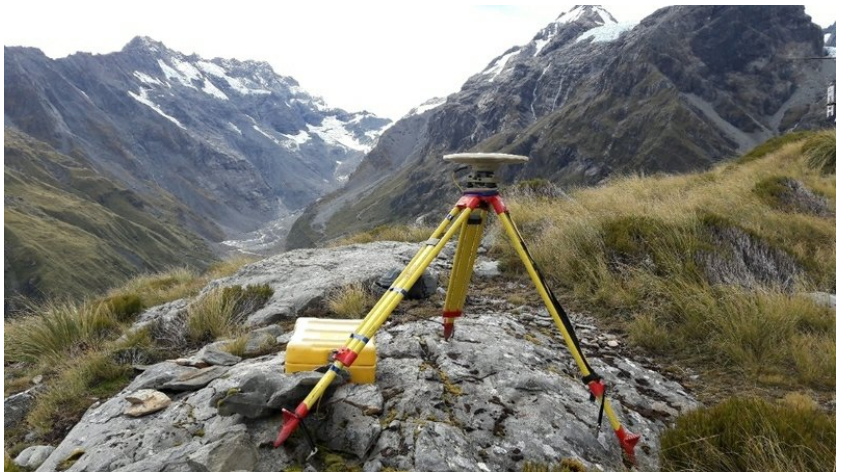
Photo of Immediate Site

| Access and Location Description | Helicopter access. Midway between Devastation Creek and Crumbling Spur and adjacent to the Smyth River at approximately 1280m. On a high terrace area, probably a remnant of glaciation. |
