## B8XX, Butler Saddle Tarn

| Project | 2018 CSI GPS |
| Geodetic Code | B8XX |
| Station Name | Butler Saddle Tarn |

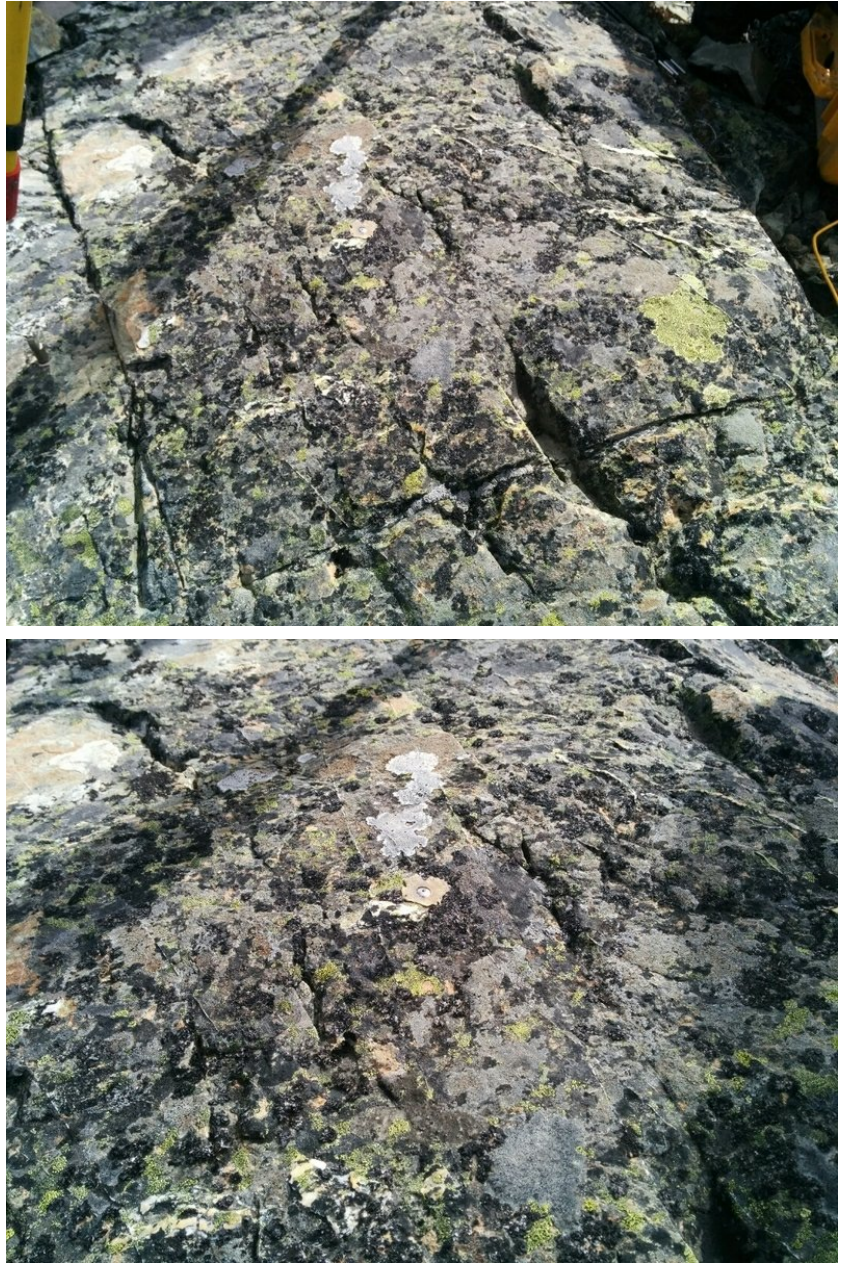
Photo of Survey Mark

| Mark Description | This mark is used for deformation monitoring, do not alter the ground mark in any way. Stainless steel pin set in rock outcrop. 3 x dynabolts installed. |

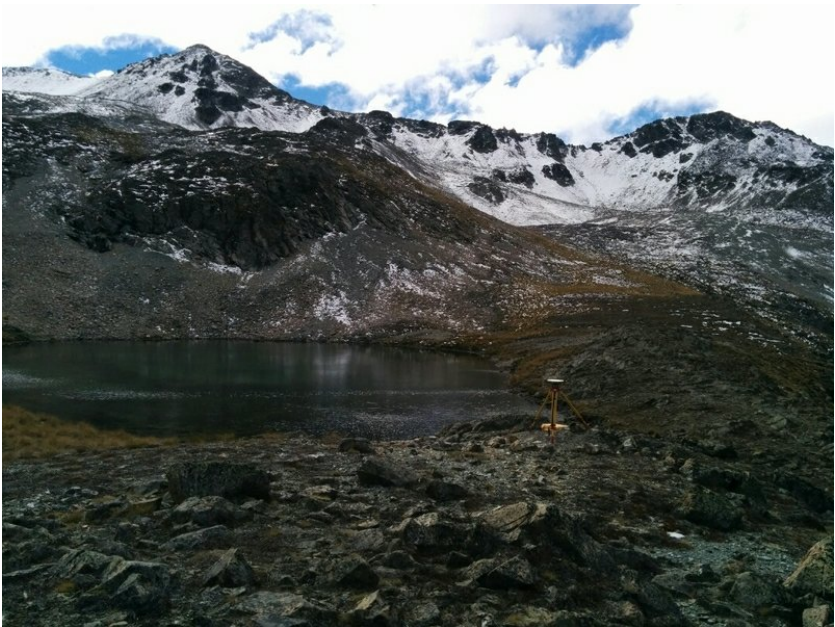
Photo of Extended Site

| Access and Location Description | Helicopter access. Located on Ben McLeod Range near Butler Saddle. Fly South Westward up Butlers Creek to the NW of the Ben McLeod Range towards Butler Saddle. After crossing the saddle turn Westwards and fly over a sharp ridge. A small tarn will soon be visible, less than 1km after crossing the ridge. The mark is on a knoll at the mouth of the tarn, on the true right bank of the stream. It is marked by a small rock cairn (1996). |
