## B8K9, Windbag (SB95)

| Project | 2018 CSI GPS |
| Geodetic Code | B8K9 |
| Station Name | Windbag (SB95) |

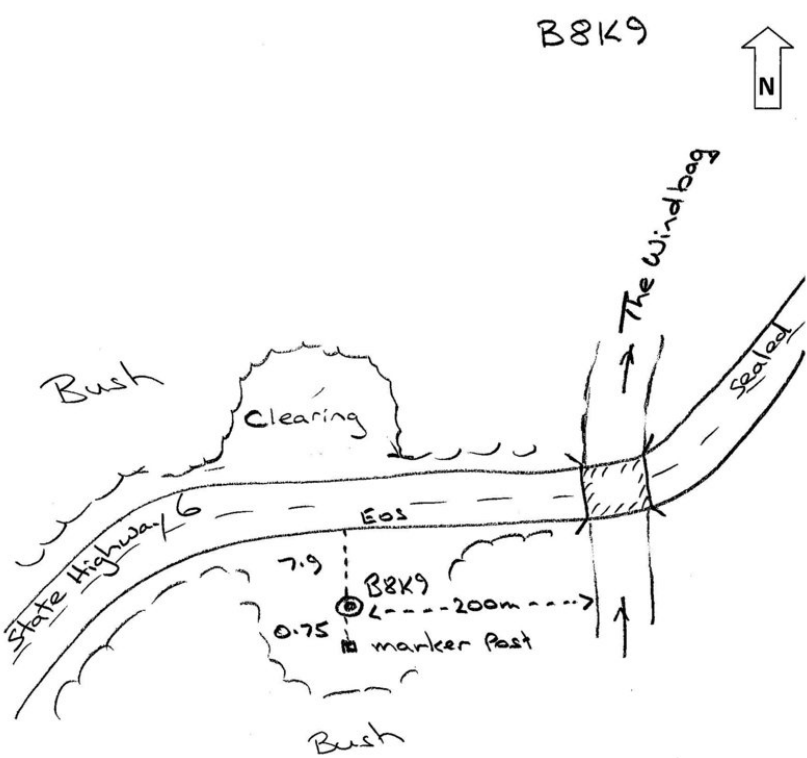
Diagram

| Access and Location Description | On south side of State Highway 6 approx 200m south of The Windbag bridge. 0.40km south of BM SB 94 on the south side of SH6 opposite Windbag Fundamental |

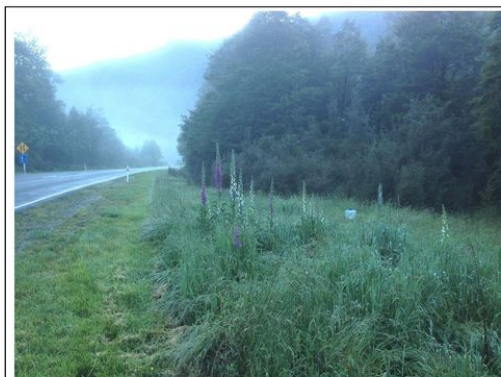
B8K9 – SB 95

| Mark Description | This mark is used for deformation monitoring, do not alter the ground mark in any way. SS pin set in concrete block up 15cm (Benchmark SB95) |

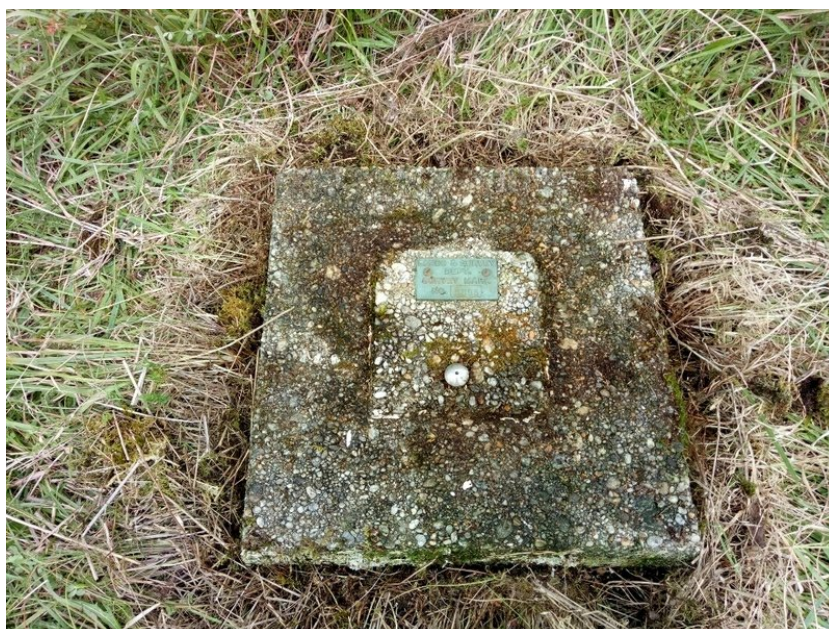
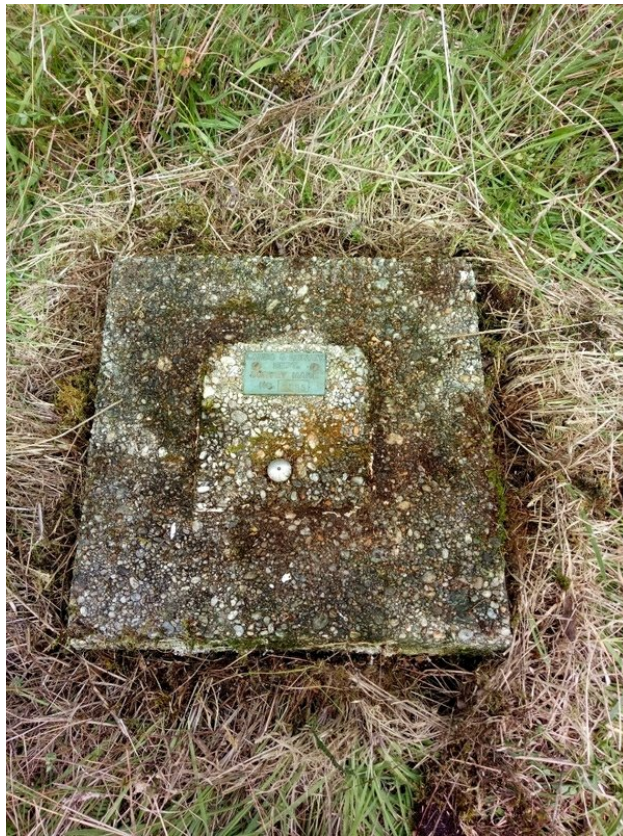
Photo of Survey Mark

| Mark Type | Stainless Steel Pin |
| Mark Physical State | Reliable / Found |

| Description | ID plaque and plate need to be installed |

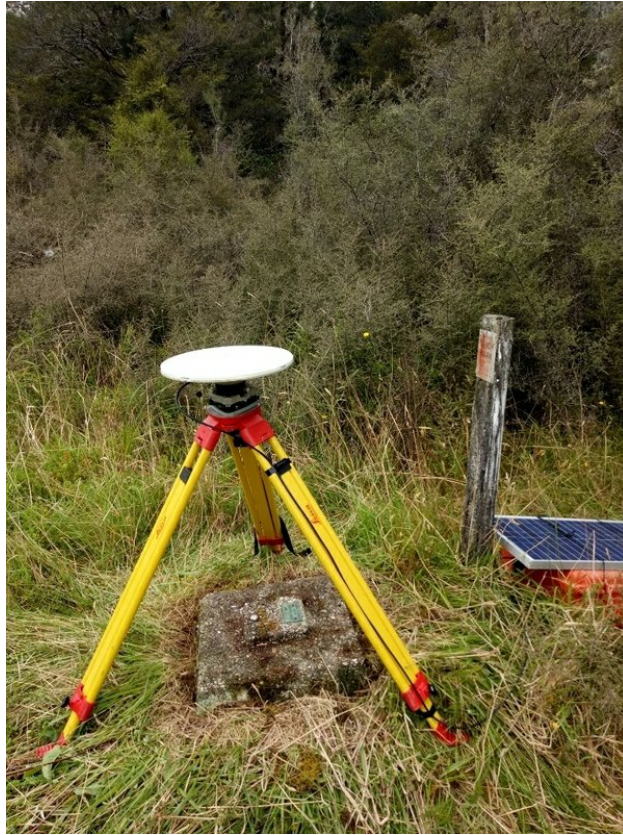
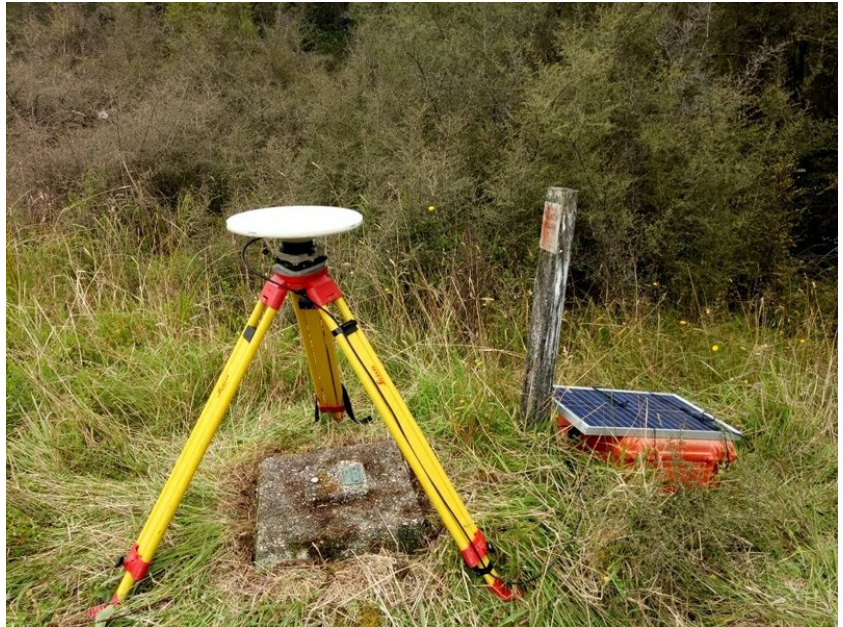
Photo of Immediate Site

| Primary Protection | Wooden or Non-Standard Marker Post |
